**Home Systems Data, Inc.**  
**7305 E. Peakview Ave.**  
**Centennial, CO 80111**  
**303-773-6102**  
**office@hsdi.us**

Client Information: Record Number 3966

**Barnes, Dave and Tracy**  
**3968 Vrain Street**  
**Denver, CO 80212**

Inspected 6/27/11 9:00 AM 2011 circa vacant new construction. Weather clear 70 degrees.  
Dave, Tracy and Sarah were present. 350.00 inspection fee pd/cc.

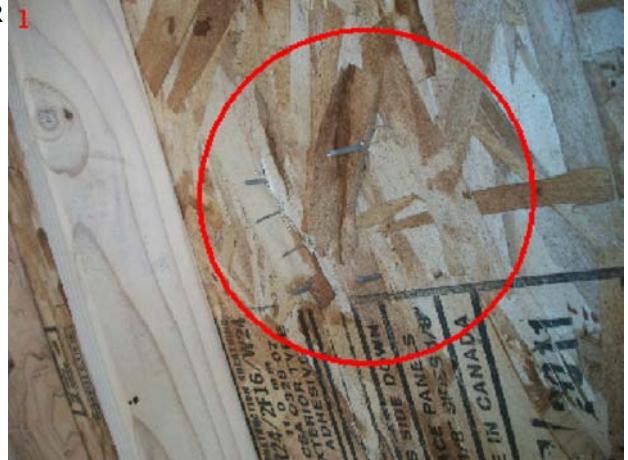
EXPOSED NAIL OR STAPLES DRIVEN THROUGH THE INTERIOR WALLS NEED TO BE COVERED.

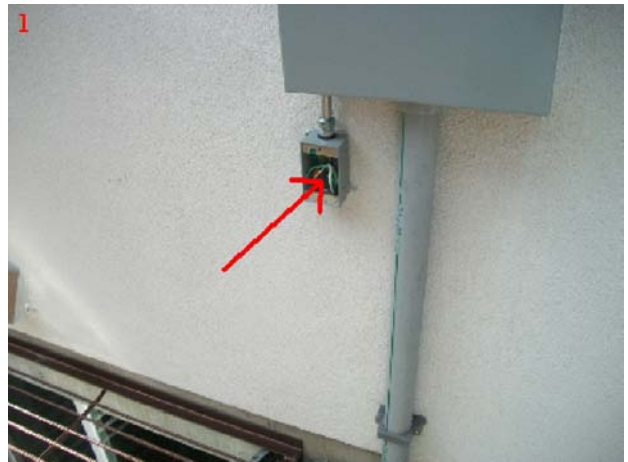
RECEPTACLE NEEDED AT THE EXTERIOR JUNCTION BOX.  
GFCI IS REQUIRED.

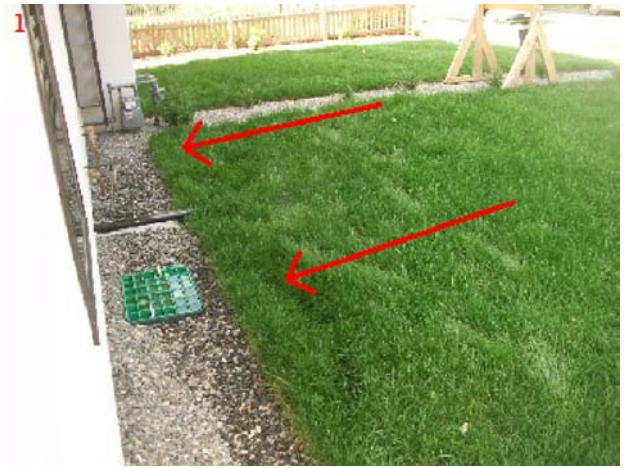
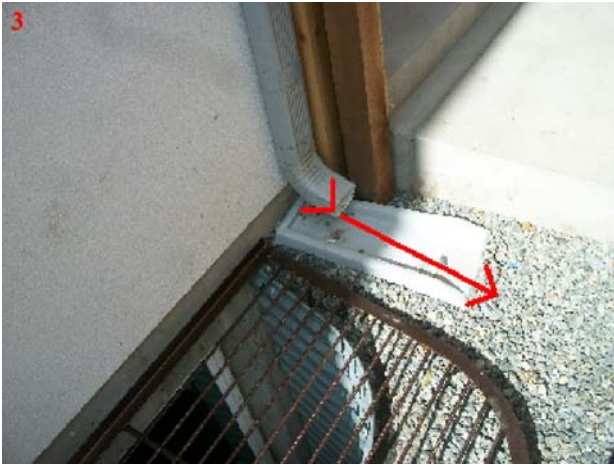
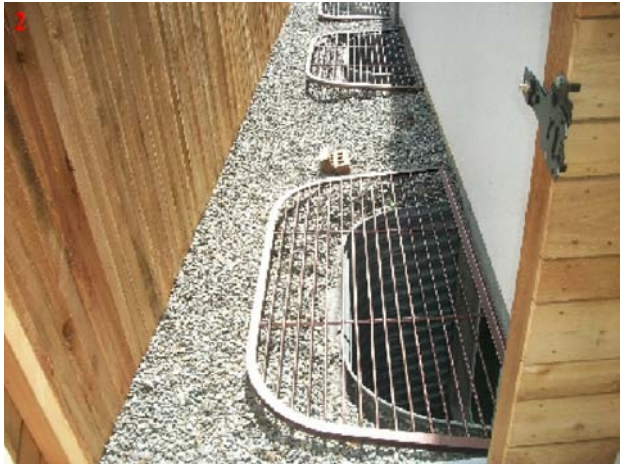
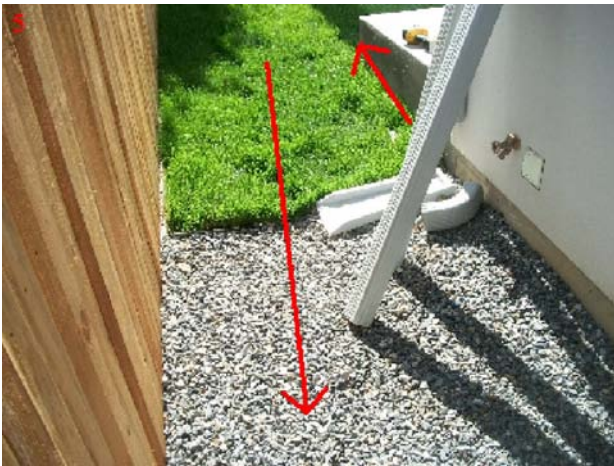
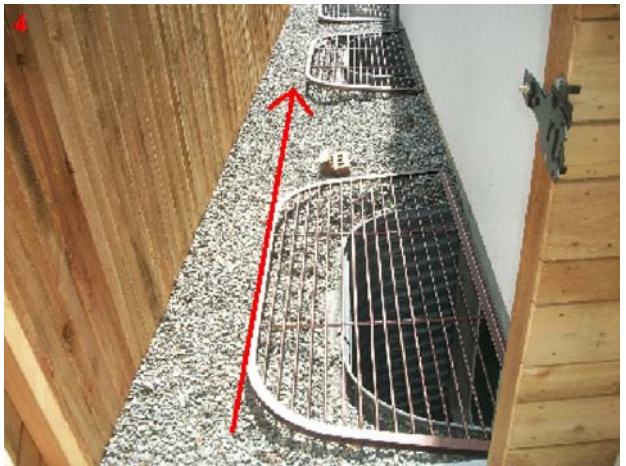
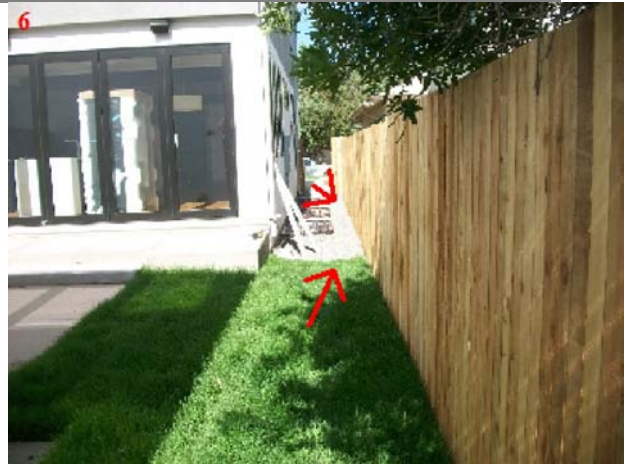
ISOLATED AREAS NEAR THE FOUNDATION WERE WATER CAN COLLECT, SOIL SHOULD BE SLOPED AWAY. POOR DRAINAGE AROUND THE FOUNDATION SHOULD BE CORRECTED BY ADDITIONAL SOIL INSTALLED AND COMPACTED TO CREATE A POSITIVE FLOW OF WATER AWAY FROM THE FOUNDATION. IF WATER IS ALLOW TO ACCUMULATE AROUND OR NEAR THE FOUNDATION WATER IN THE BASEMENT COULD OCCUR. THE WEST FRONT, NORTH SIDE OF THE DUPLEX HAS POOR GRADE ALLOWING WATER TO COLLECT NEAR THE FOUNDATION. IT IS ADVISED TO HAVE THE DESIGNING ENGINEER AND OR ARCHITECT REVIEW TO DESIGN, IMPLEMENT AND SUPERVISE CORRECTIVE MEASURES.

ISOLATED AREAS NEAR THE FOUNDATION WHERE WATER CAN COLLECT, SOIL SHOULD BE SLOPED AWAY. POOR DRAINAGE AROUND THE FOUNDATION SHOULD BE CORRECTED BY ADDITIONAL SOIL INSTALLED AND COMPACTED TO CREATE A POSITIVE FLOW OF WATER AWAY FROM THE FOUNDATION. IF WATER IS ALLOWED TO ACCUMULATE AROUND OR NEAR THE FOUNDATION WATER IN THE BASEMENT COULD OCCUR. THE WEST FRONT, NORTH SIDE OF THE DUPLEX HAS POOR GRADE ALLOWING WATER TO COLLECT NEAR THE FOUNDATION. IT IS ADVISED TO HAVE THE DESIGNING ENGINEER AND OR ARCHITECT REVIEW TO DESIGN, IMPLEMENT AND SUPERVISE CORRECTIVE MEASURES.

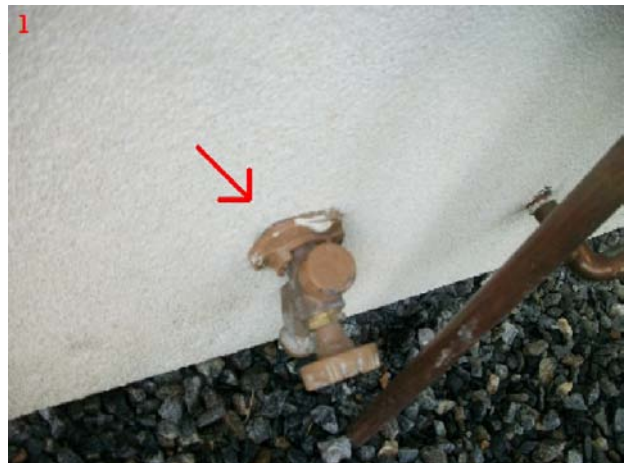
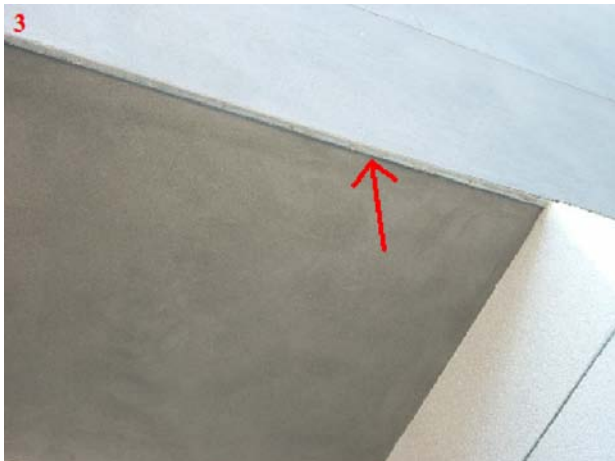
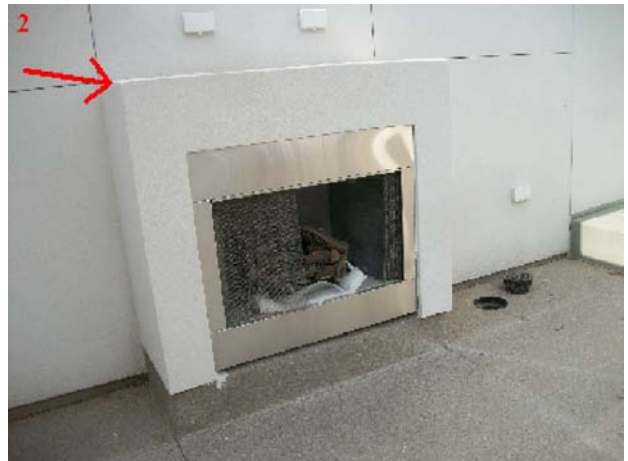
IT IS RECOMMENDED TO HAVE AN EDI (EXTERIOR DESIGN INSTITUTE) INSPECTOR OR LICENSED STUCCO CONTRACTOR REVIEW AND DESIGN AND MODIFY HARD COAT STUCCO SYSTEM AS NECESSARY, TO INCLUDE BUT NOT LIMITED TO: CAULKING AT ALL THE ATTACHEMENTS AND PENETRATIONS, STONE CAP ADVISED ON THE FIREPLACE WITH DRIP EDGE. FYI: DRAIN HOLES ON THE BOTTOM EDGE OF ALL THE STUCCO.

IT IS RECOMMENDED TO HAVE AN EDI (EXTERIOR DESIGN INSTITUTE) INSPECTOR OR LICENSED STUCCO CONTRACTOR REVIEW AND DESIGN AND MODIFY HARD COAT STUCCO SYSTEM AS NECESSARY, TO INCLUDE BUT NOT LIMITED TO: CAULKING AT ALL THE ATTACHEMENTS AND PENETRATIONS, STONE CAP ADVISED ON THE FIREPLACE WITH DRIP EDGE.  
FYI: DRAIN HOLES ON THE BOTTOM EDGE OF ALL THE STUCCO.

SEE STUCCO SECTION: ALL PENETRATIONS, MATERIAL CHANGES AND ATTACHMENTS TO THE STUCCO SHOULD BE CAULKED WITH APPROPRIATE MATERIAL.

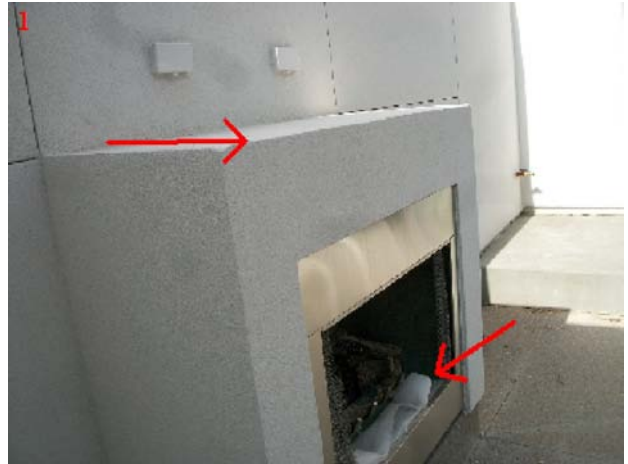
THE EXTERIOR FIREPLACE IS NOT COMPETED FOR TESTING.  
STONE OR OTHER SOLID CAP WITH DRIP EDGE IS ADVISED.

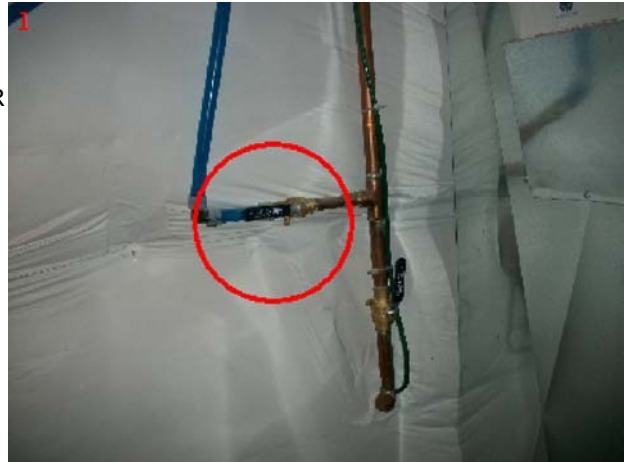
TIMER LOCATED: GARAGE 2 ZONES  
ANTI SIPHON VALVE LOCATED: NORTH EXTERIOR  
RECOMMEND THAT ANTI SIPHON AND WATER VALVES BE  
PLACED 5' FROM FOUNDATION, OR BUILDER PROVIDE LETTER  
FROM FOUNDATION DESIGNING ENGINEER APPROVING  
LOCATION.  
MAIN VALVE LOCATED: BASEMENT  
SPRINKLER SYSTEM MUST BE WINTERIZED BEFORE FIRST  
SEASON FREEZE, USUALLY OCTOBER 15+/-.

TIMER LOCATED: GARAGE 2 ZONES  
ANTI SIPHON VALVE LOCATED: NORTH EXTERIOR  
RECOMMEND THAT ANTI SIPHON AND WATER VALVES BE PLACED 5' FROM FOUNDATION, OR BUILDER PROVIDE LETTER FROM FOUNDATION DESIGNING ENGINEER APPROVING LOCATION.  
MAIN VALVE LOCATED: BASEMENT  
SPRINKLER SYSTEM MUST BE WINTERIZED BEFORE FIRST SEASON FREEZE, USUALLY OCTOBER 15+/-.

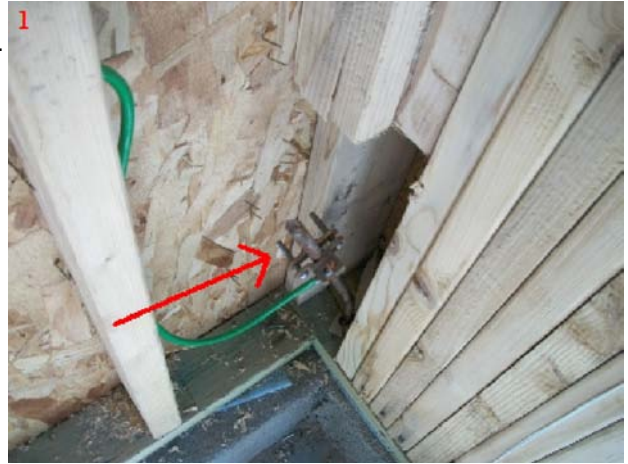
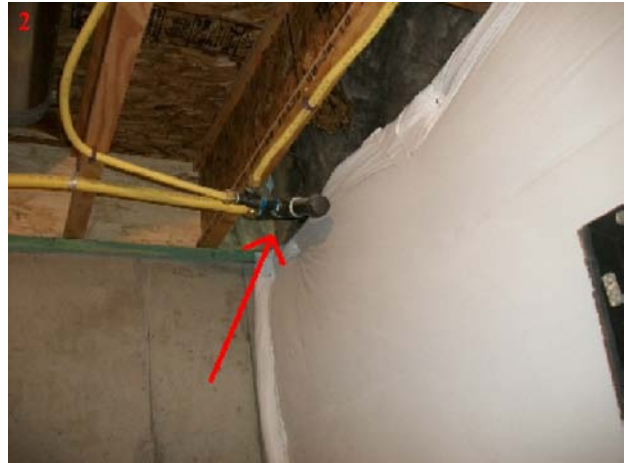
GROUNDING REBAR IN THE GARAGE.  
ELECTRICIAN VERIFY PROPER GROUNDING OF THE GAS LINE.

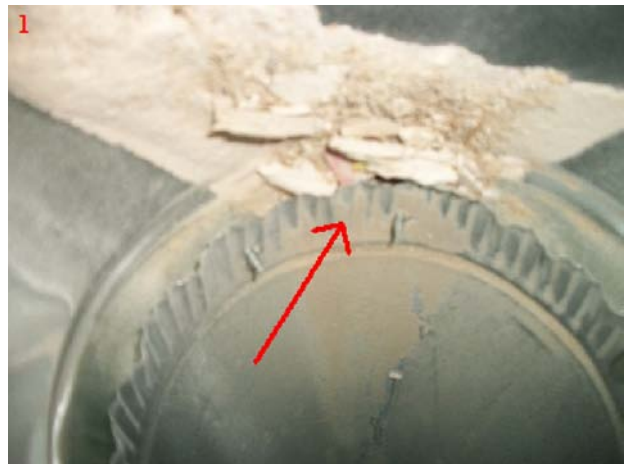
DUCTS NEED PROFESSIONAL CLEANING.

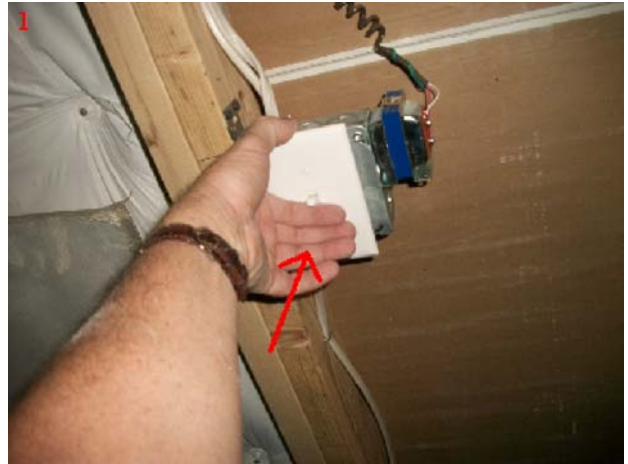
RECOMMEND LABELING SWITCH.

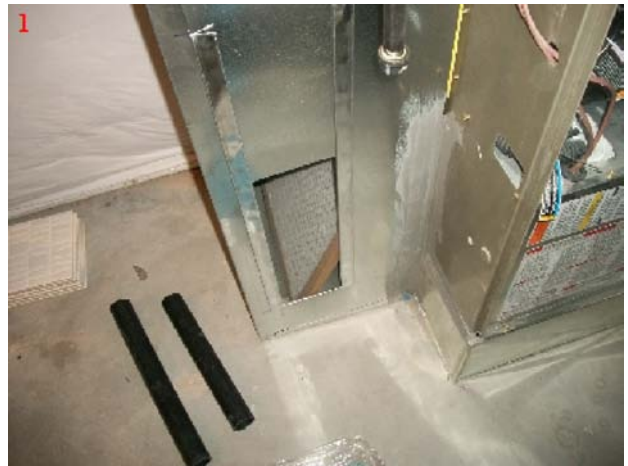
IT IS NOT RECOMMENDED TO USE THE HEPA STYLE OR ALLERGY STYLE FILTERS DURING THE AIR CONDITIONING SEASON, THESE FILTERS REDUCE THE AIR FLOW SEVERELY AND CAN CAUSE SYSTEM TO FREEZE UP OR HAVE POOR PERFORMANCE.  
FURNACE FILTER NEEDS CHANGED.  
LABEL SIZE, PLACEMENT AND AIR FLOW DIRECTIONS ON THE ACCESS AREA.

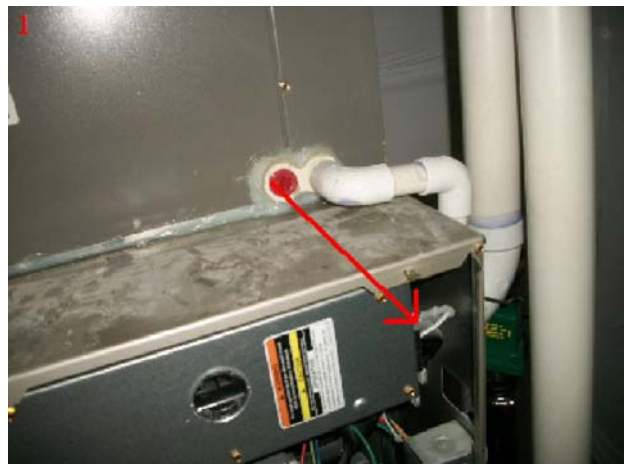
CONDENSATION SECONDARY DISCHARGE LINE IS NOT REQUIRED BUT RECOMMENDED. THIS SECONDARY DRAIN WILL ALERT TO CLOGGED PRIMARY.

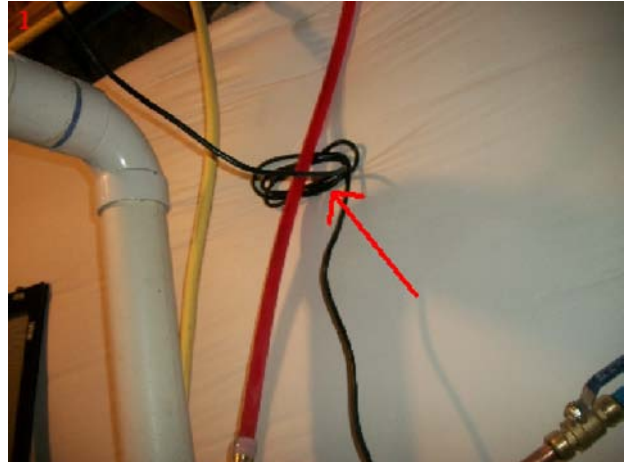
PROPERLY SECURE THE EXTRA POWER CORD.

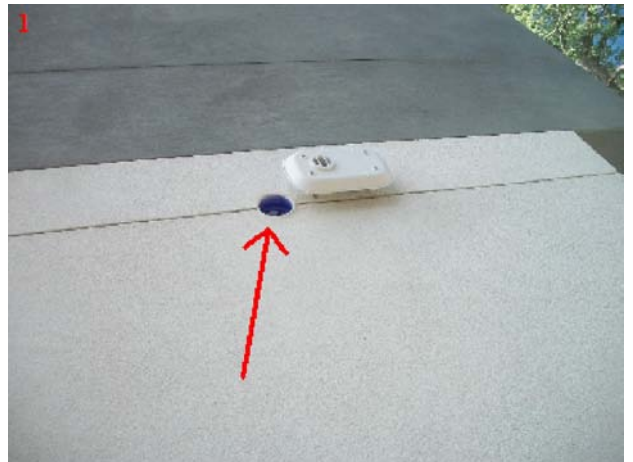
ELBOW ON THE EXTERIOR EXHAUST ADVISED.

**Service/Repair** Water Heater Vent Pipe - PVC  
ELBOW ON THE EXTERIOR EXHAUST ADVISED.

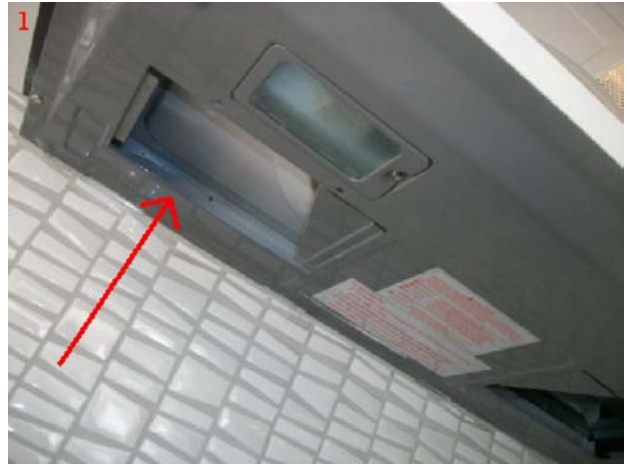
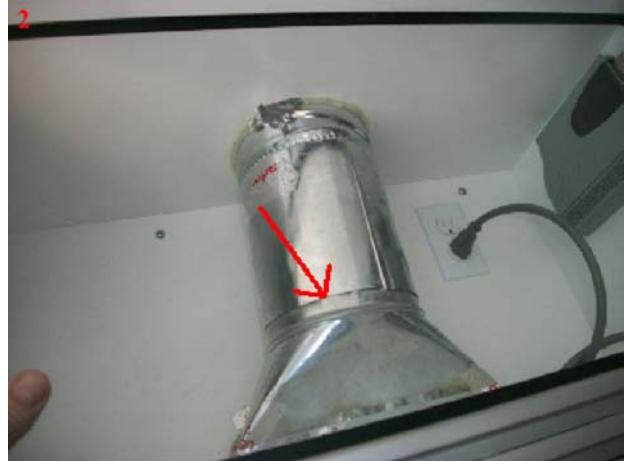
INSTALL FILTERS IN THE VENT.  
FOIL TAPE NEEDED ON THE JOINTS IN THE CABINET.

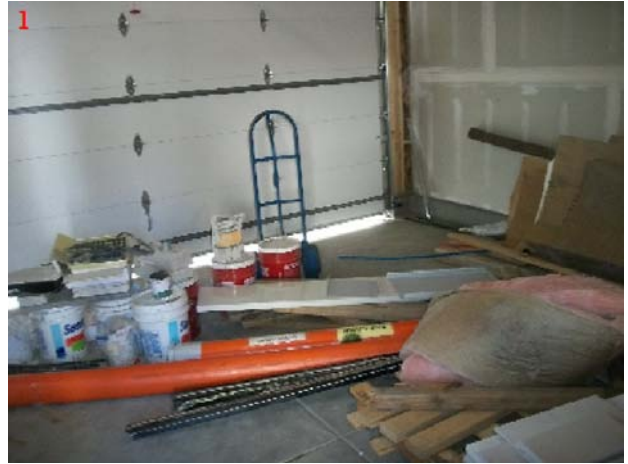
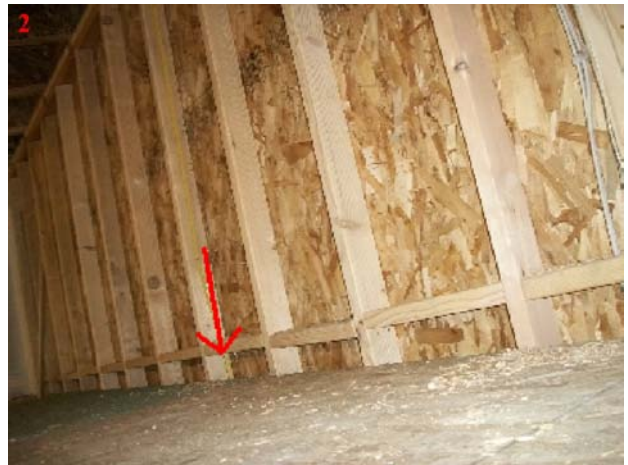
PURCHASER TO CHECK VEHICLE SIZE TO MAKE SURE THEY WILL FIT IN THE GARAGE.  
PERSONAL PROPERTY AND STORAGE LIMITS INSPECTION.  
GARAGE TO BE CLEAN OF ALL CONSTRUCTION MATERIAL AND DEBRIS.  
LOFT ARE NEEDS CLEANED AND REMOVABLE RAILING ADVISED.

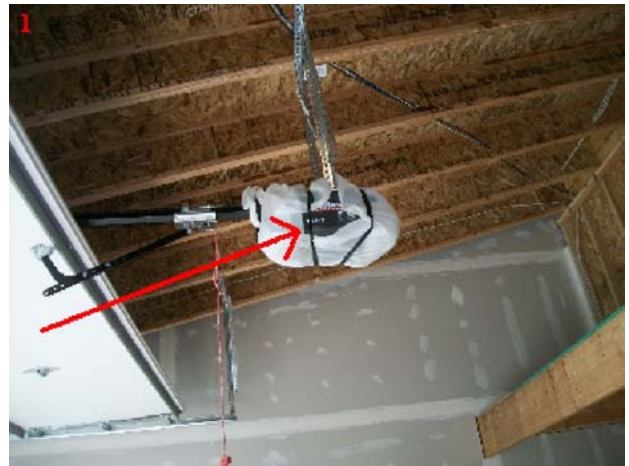
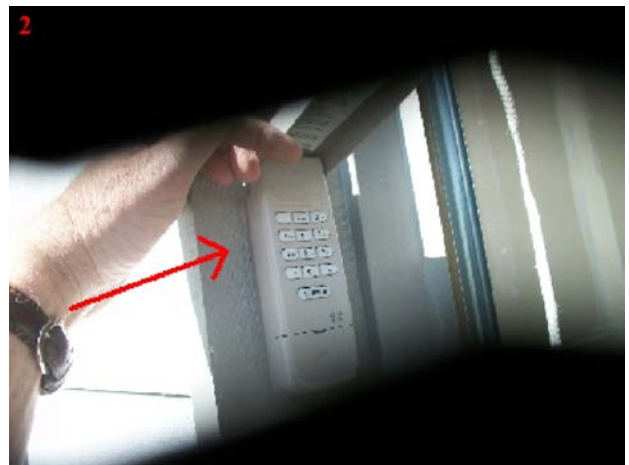
ELECTRIC GARAGE DOOR OPENER IS MALFUNCTIONING.  
SERVICE BY QUALIFIED PERSON AS NEEDED.  
TRANSMITTERS NOT LOCATED.  
PURCHASER WILL NEED THE CODE FOR THE KEYLESS PAD.  
LUBRICATE THE TRACKS PERIODICALLY.  
UNIT NEEDS UNPACKED.

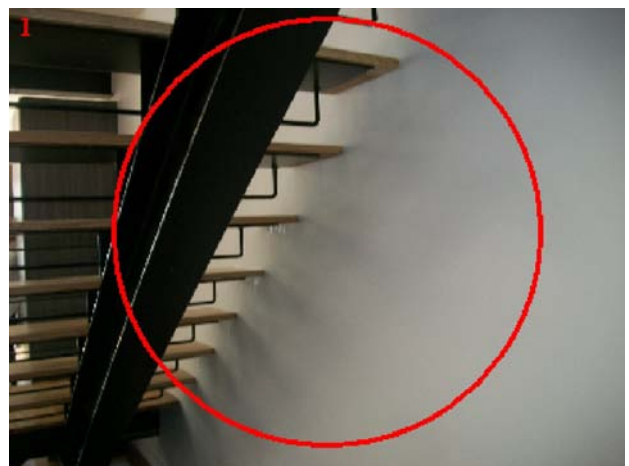
GENERAL TOUCH UP.  
VARNISH RUNS AT STAIR TREADS.

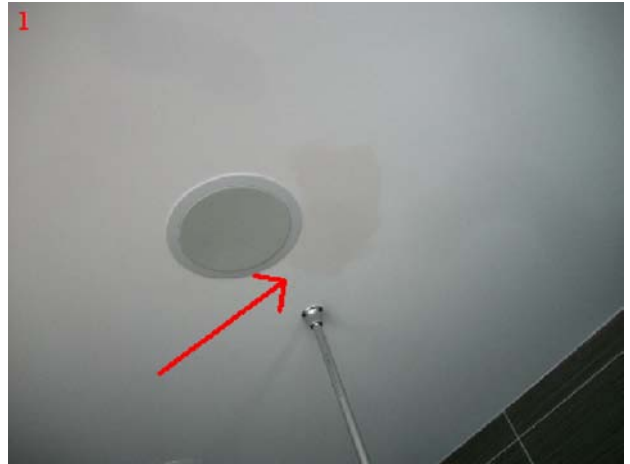
GENERAL TOUCH UP.  
SPECIAL ATTENTION TO THE STAIRWELL, GUEST BEDROOM  
AND MASTER BATHROOM CEILING.

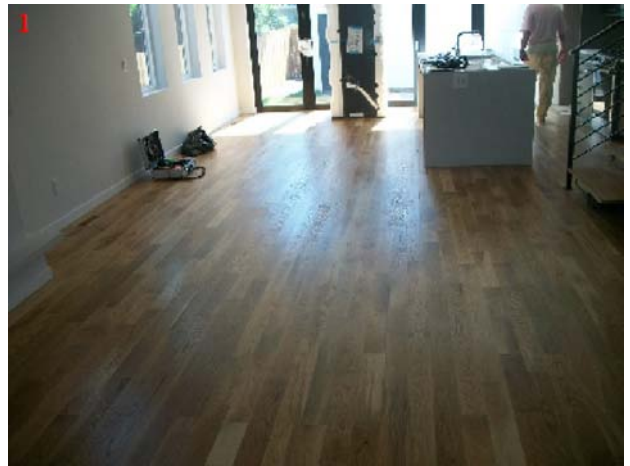
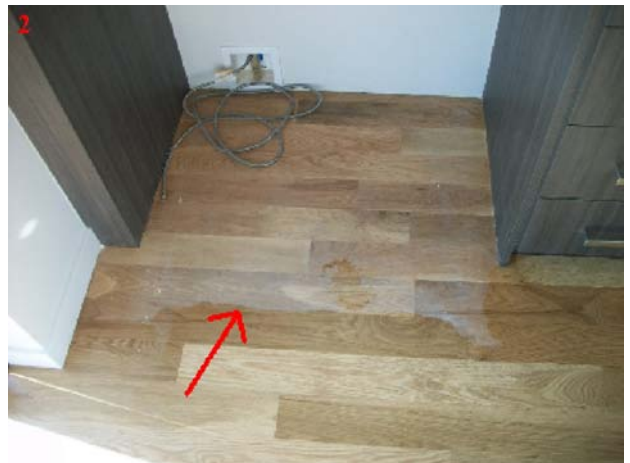
REPORTED BY THE BUILDER THE FLOORS HAVE RECEIVED  
THEIR FINAL SCREEN AND COATING, THE AREA AROUND THE  
REFRIGERATOR NEEDS COMPLETED THE THE HARDWOOD  
FINISH DOES NOT APPEAR CONSISTENT.

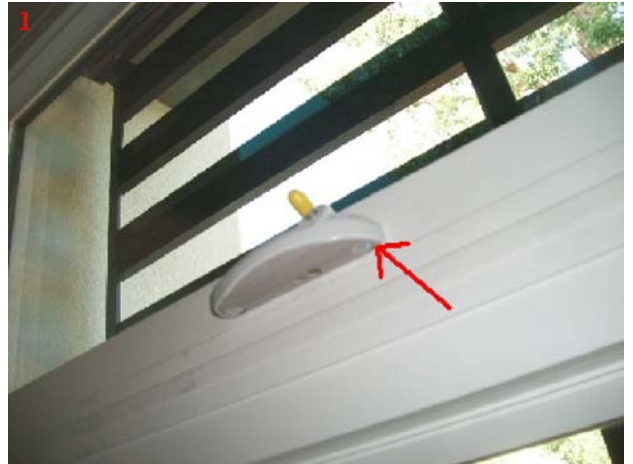
MISSING HAND CRANKS.  
REVIEW AND COMPLETE ALL ADJUSTMENTS.

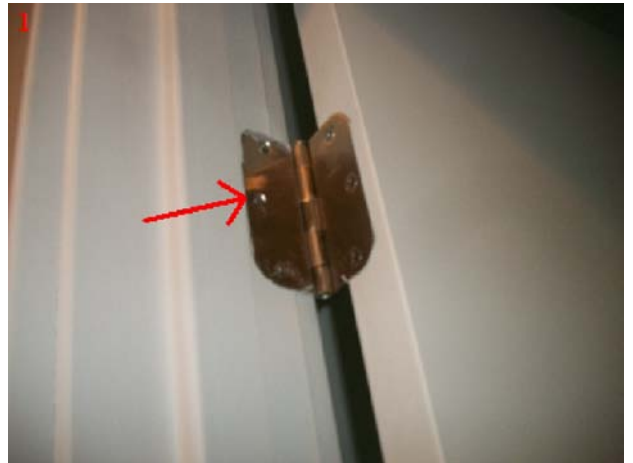
BASEMENT WEST BEDROOM DOOR HINGE SCREWS ARE STRIPPED.  
REVIEW ALL INTERIOR DOORS AND ADJUST AS NECESSARY TO OPERATE PROPERLY.

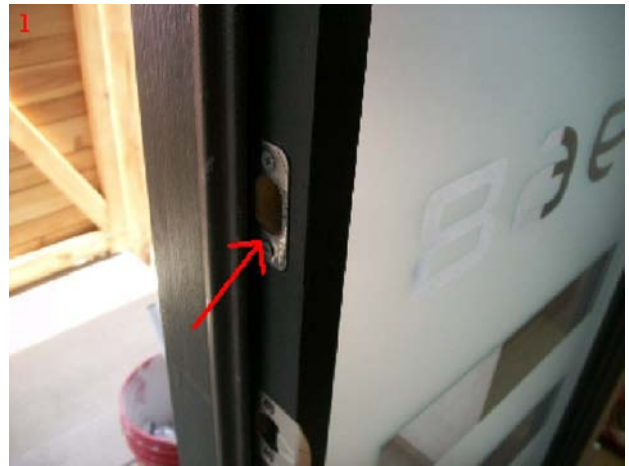
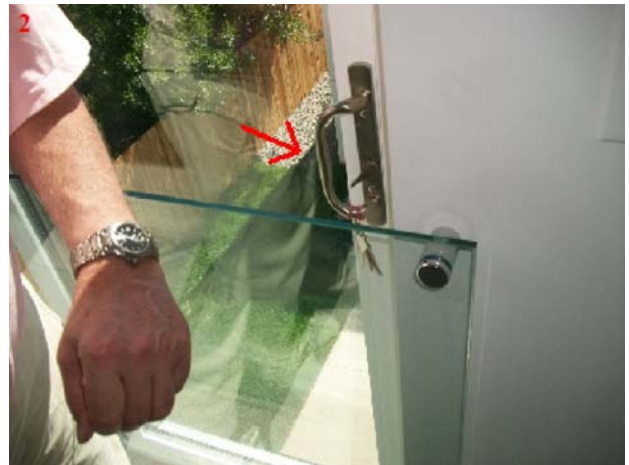
FRONT DOOR DEAD BOLD TO NOT LATCHING.  
SCREEN NEEDED ON THE MASTER SLIDER.  
REFRIGERATOR RESTRICTED TESTING THE FAMILY ROOM  
FOLDING DOORS.

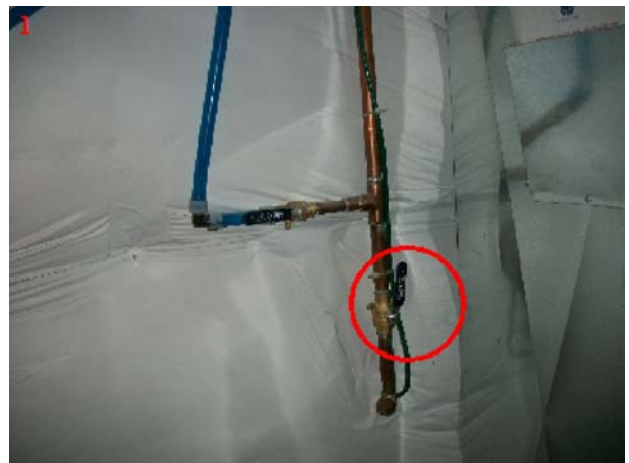
LABEL ALL VALVES AT THE MAIN ENTRY POINT.

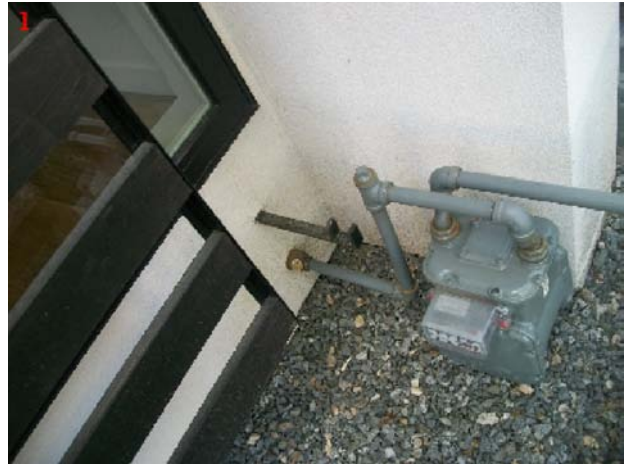
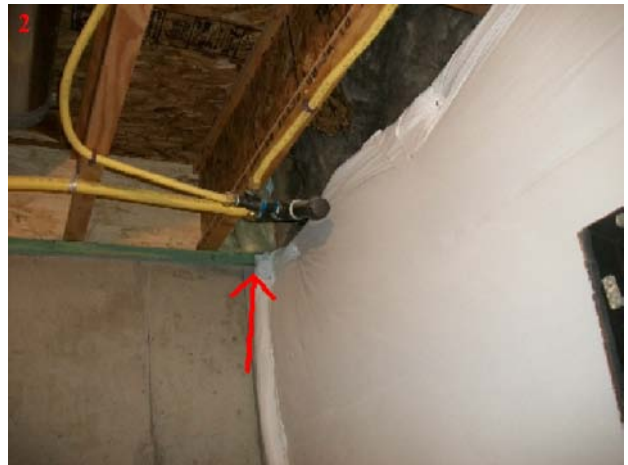
GAS METER IS LOCATED: EXTERIOR  
GAS DISCONNECT VALVES ARE AT EACH APPLIANCE AND AT THE EXTERIOR METER.  
NATIONAL ELECTRICAL CODE 310.1 CSST CORRUGATED STAINLESS STEEL TUBING GAS PIPING SYSTEMS SHALL BE BONDED TO THE ELECTRICAL SERVICE GROUNDING ELECTRODE SYSTEM, ELECTRICAL CONTRACTOR VERIFY PROPER GROUNDING OF THE PIPING.

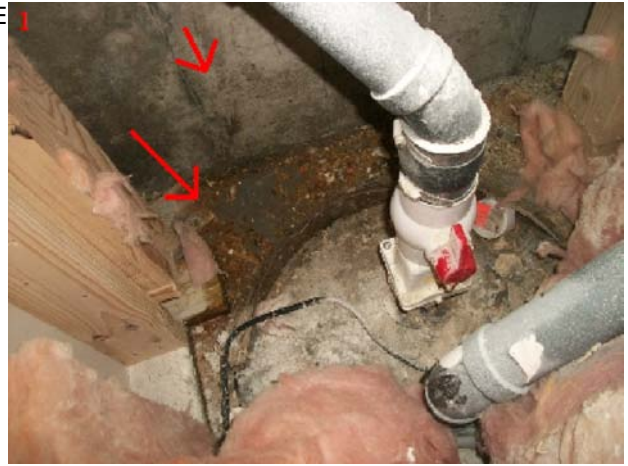
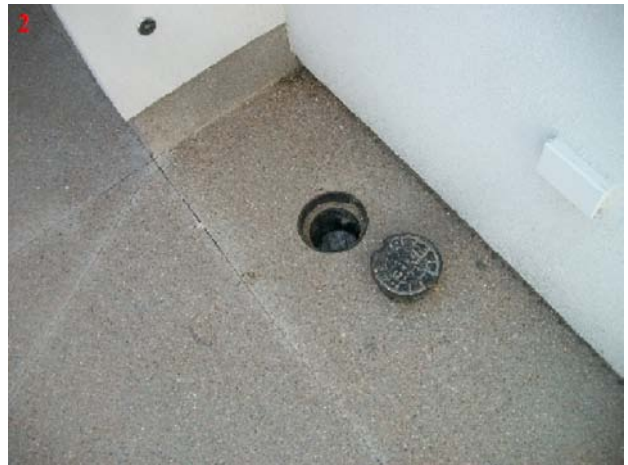
THE CONDITION OF THE MAIN SEWER LINE UNDER CONCRETE OR EARTHEN DIRT CANNOT BE DETERMINED. A CAMERA INSPECTION CAN BE PROVIDED BY SEPARATE CONTRACTOR. SEWAGE WATER LEAKING DOWN PIPE AND OR WALL FROM A BROKEN PIPE AT THE SEWER EJECTOR SYSTEM. DRYWALL AND INSULATION WILL NEED REMOVED TO FIND AND REPAIR THE LEAK. ALL WET MATERIAL SHOULD BE REMOVED AND TREATMENT FOR ANY BIO ORGANIC MATERIAL AS NEEDED, AND THEN RESTORED TO NEW CONDITION. CLEAN OUT LOCATED AT THE REAR PATIO.

THE CONDITION OF THE MAIN SEWER LINE UNDER CONCRETE OR EARTHEN DIRT CANNOT BE DETERMINED. A CAMERA INSPECTION CAN BE PROVIDED BY SEPARATE CONTRACTOR.  
SEWAGE WATER LEAKING DOWN PIPE AND OR WALL FROM A BROKEN PIPE AT THE SEWER EJECTOR SYSTEM. DRYWALL AND INSULATION WILL NEED REMOVED TO FIND AND REPAIR THE LEAK. ALL WET MATERIAL SHOULD BE REMOVED AND TREATMENT FOR ANY BIO ORGANIC MATERIAL AS NEEDED, AND THEN RESTORED TO NEW CONDITION.  
CLEAN OUT LOCATED AT THE REAR PATIO.

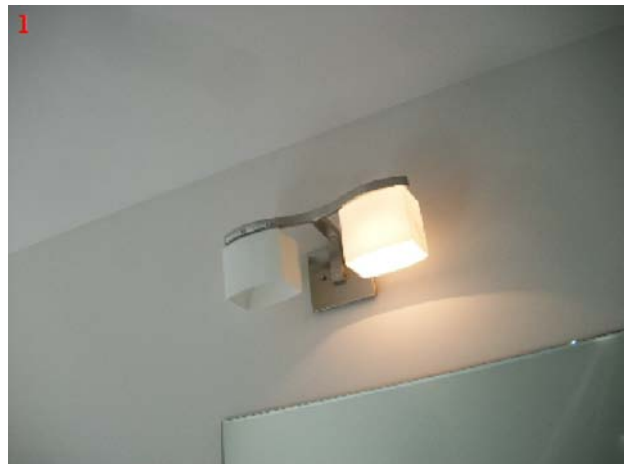
REPLACE BULBS OR FIXTURE AS NEEDED ABOVE THE SINK.

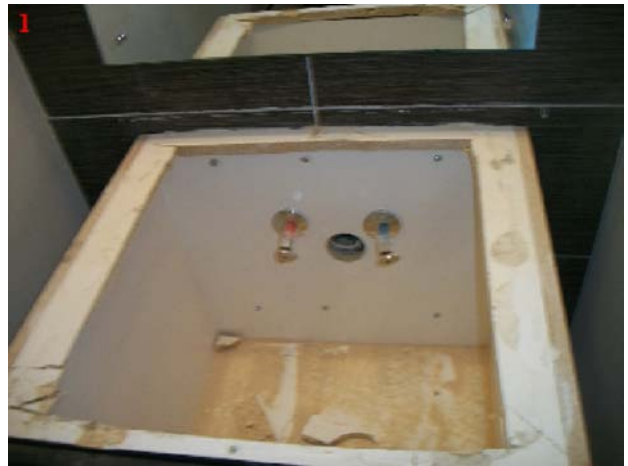
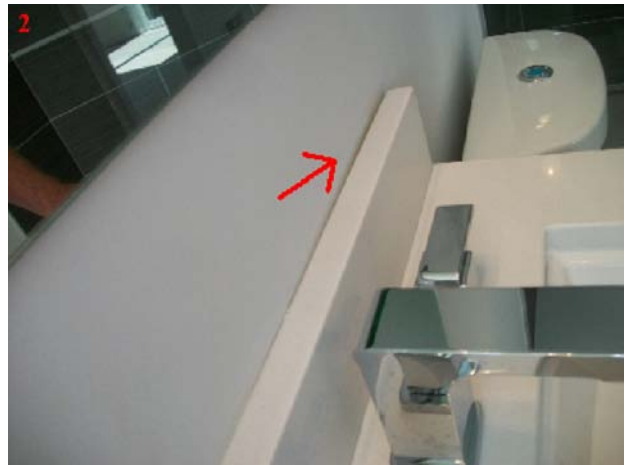
MAIN FLOOR POWDER ROOM SINK IS NOT COMPLETED.  
WHITE CAULKING NEEDED AT THE SINK BACK SPLASHES.

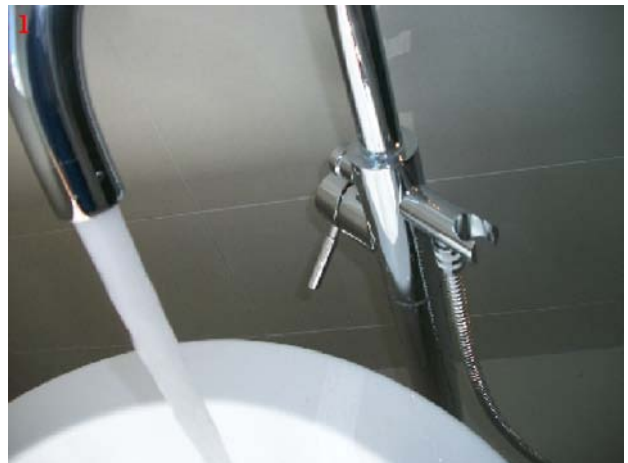
HOT AND COLD CONTROL VALVE IS REVERSED, COLD  
SHOULD COME ON FIRST AND GO TO HOT.

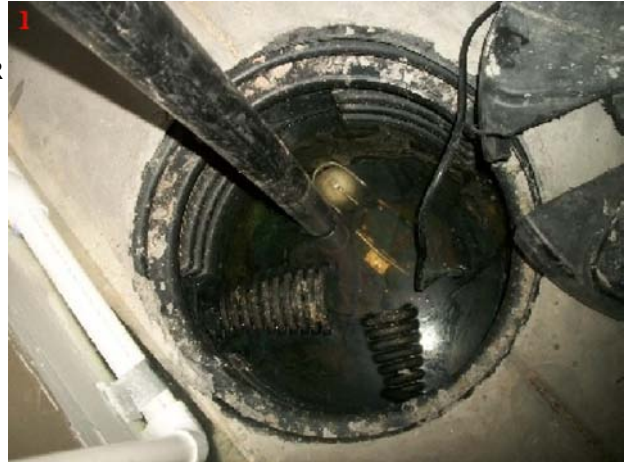
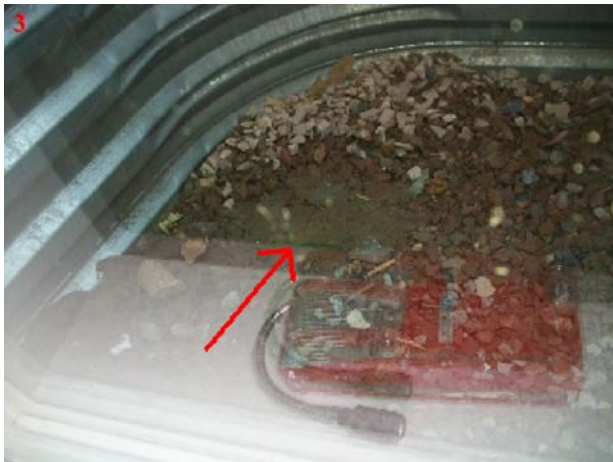
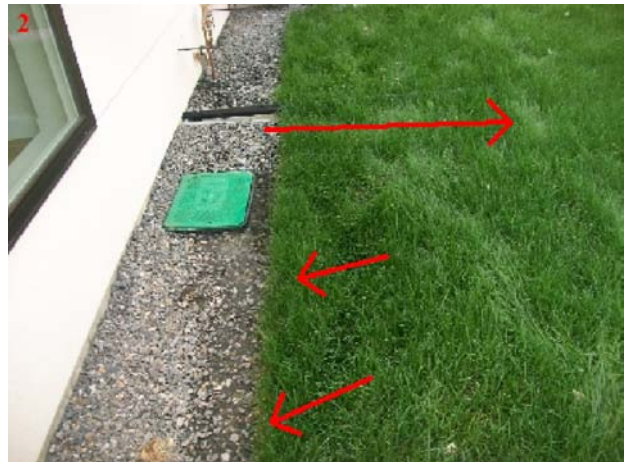
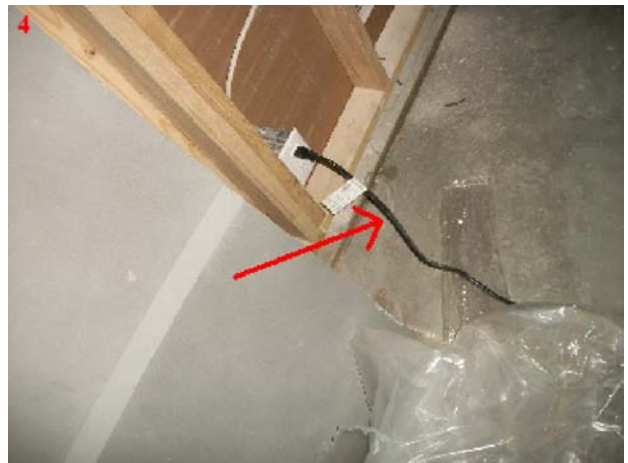
CHECK SUMP PUMP OPERATION 5 TIMES PER YEAR.  
SUMP PUMP FAILURE ALERT ALARM ADVISED.  
SUMP PUMP NEEDS A DEDICATED ELECTRICAL CIRCUIT NEAR THE PIT.  
THE DISCHARGE PIPE IS REPORTED TO BE MOVED AND RUN ALONG THE GRAVEL AREA BETWEEN THE UNITS. PIPE SHOULD BE COVERED WITH GRAVEL.  
STANDING WATER FOUND IN THE PIT, PUMP PLUGGED AND AND DRAINED HOWEVER 12" OF STANDING WATER REMAINS IN THE PIT AND THE PUMP IS SET UP ON BLOCK ABOVE THE BASE OF THE PIT WHICH IS AN INDICATION THAT THERE IS A WATER TABLE UNDER THE SUBJECT  
ADDITIONAL GRAVEL NEEDED IN THE BASE OF THE WINDOW WELLS.

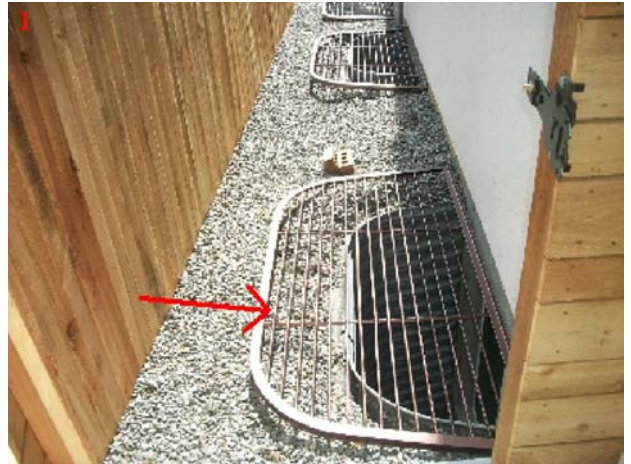
PROPER SIZE GRATE COVERS NEEDED.

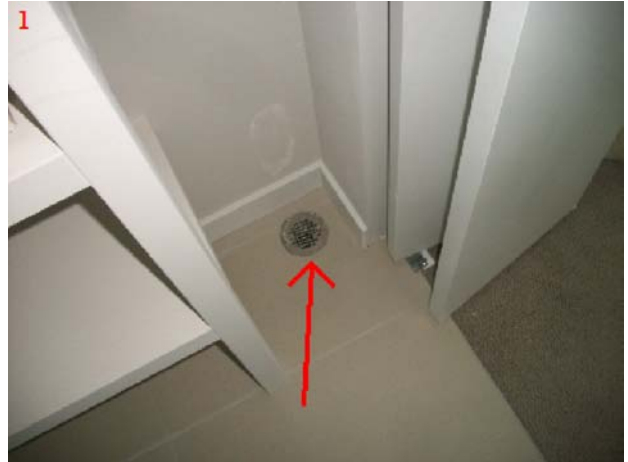
POUR WATER DOWN THE FLOOR DRAIN PERIODICALLY TO PREVENT SEWER GAS FROM ESCAPING INTO THE LAUNDRY ROOM.
