NOT ON STORM-PARCEL SPLIT 004 to 036 & 037 3968 VRAIN ST GIS IMPERVIOUS INSPECTION REPORT

PREPARED ON : 7/25/2011

Schedule Number: 62-0219318037000

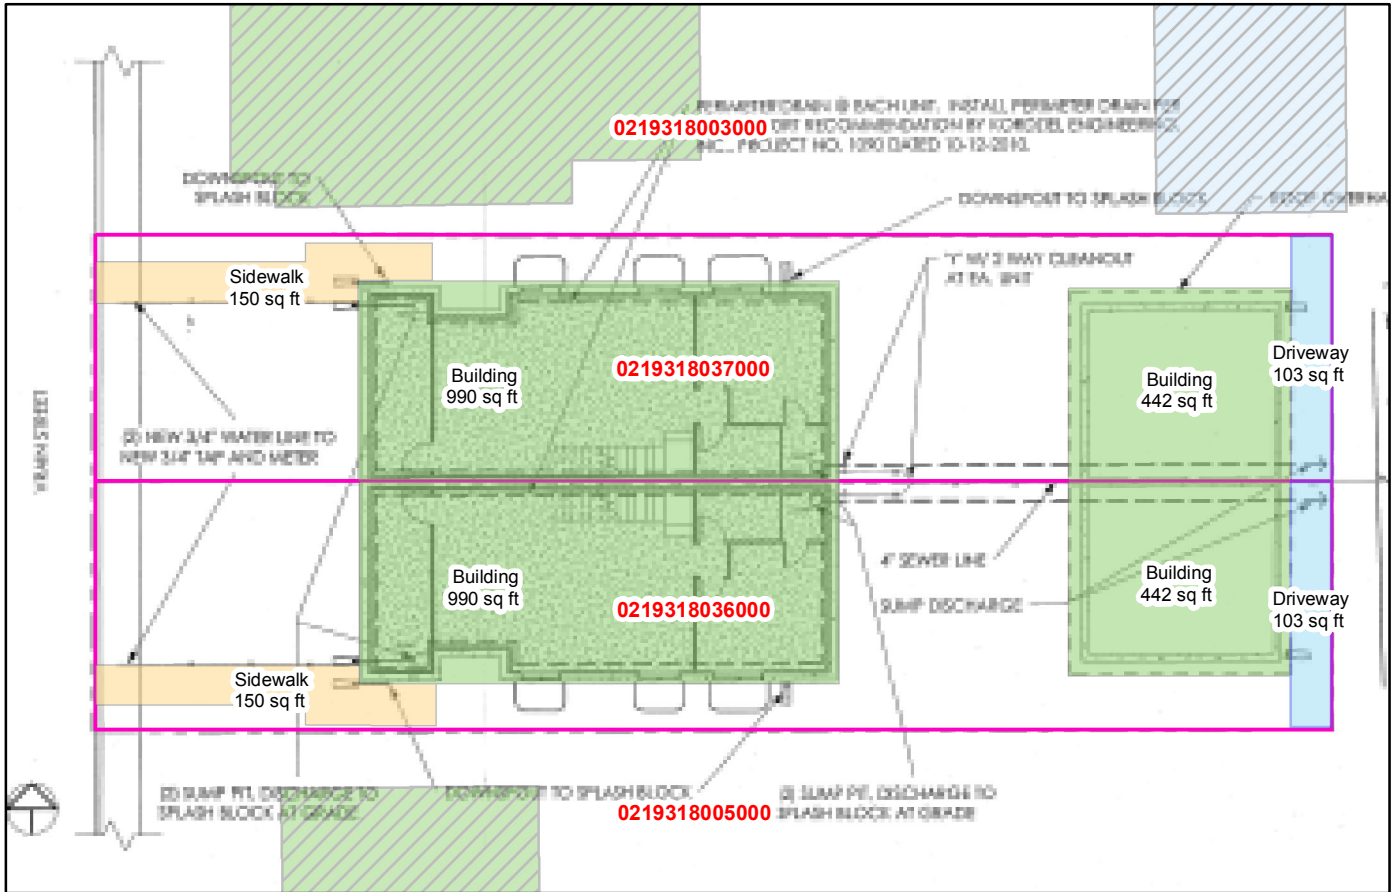
Building -	1,432
Driveway -	103
Sidewalk -	150
Parking -	0
Other -	0
Grand Total -	1,685
Assessor Parcel Area -	3,125
